Forensic Engineering and Visualization

4215.Goodnight
June 22, 2021

Report

Case Name: Waterdown v. Mesilla Valley
Date of Incident: May 13, 2018

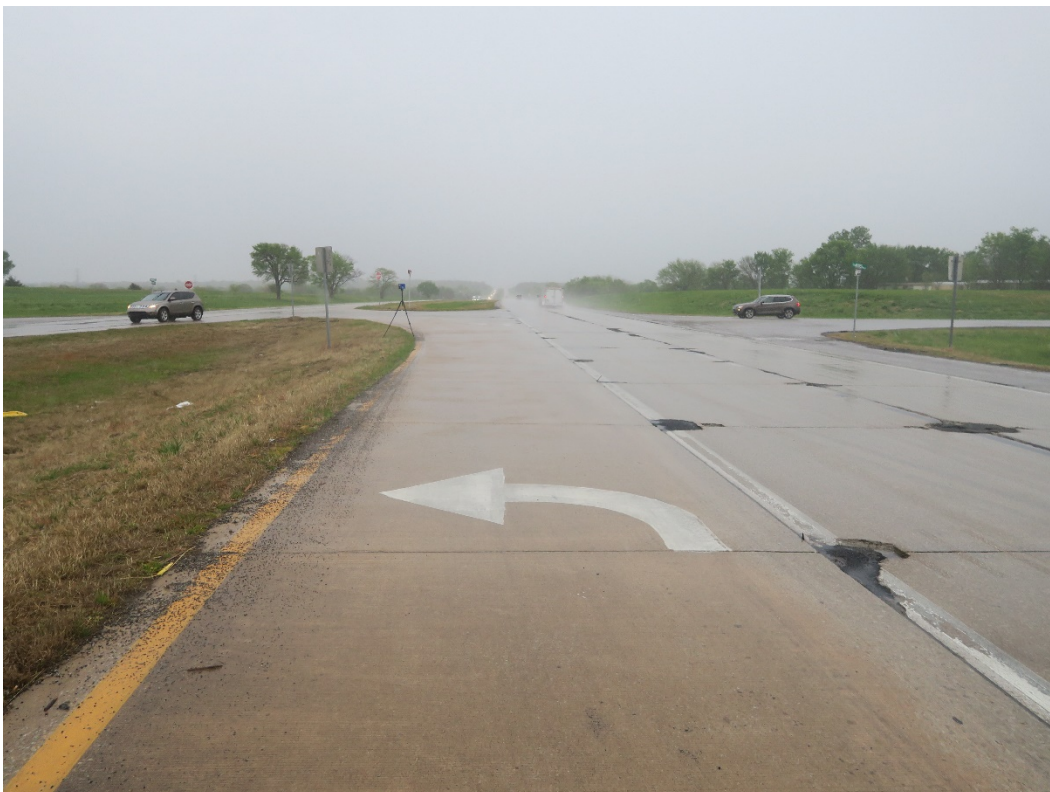
Figure 4 - KinetiCorp Scene Inspection Looking Eastbound on U.S. Highway 412

Scene Inspection: On April 16, 2021, KinetiCorp performed a scene inspection on the incident site. Figure 4 is a photograph taken at the time of the inspection looking eastbound on U.S. Highway 412 near the intersection with County Road 4115.

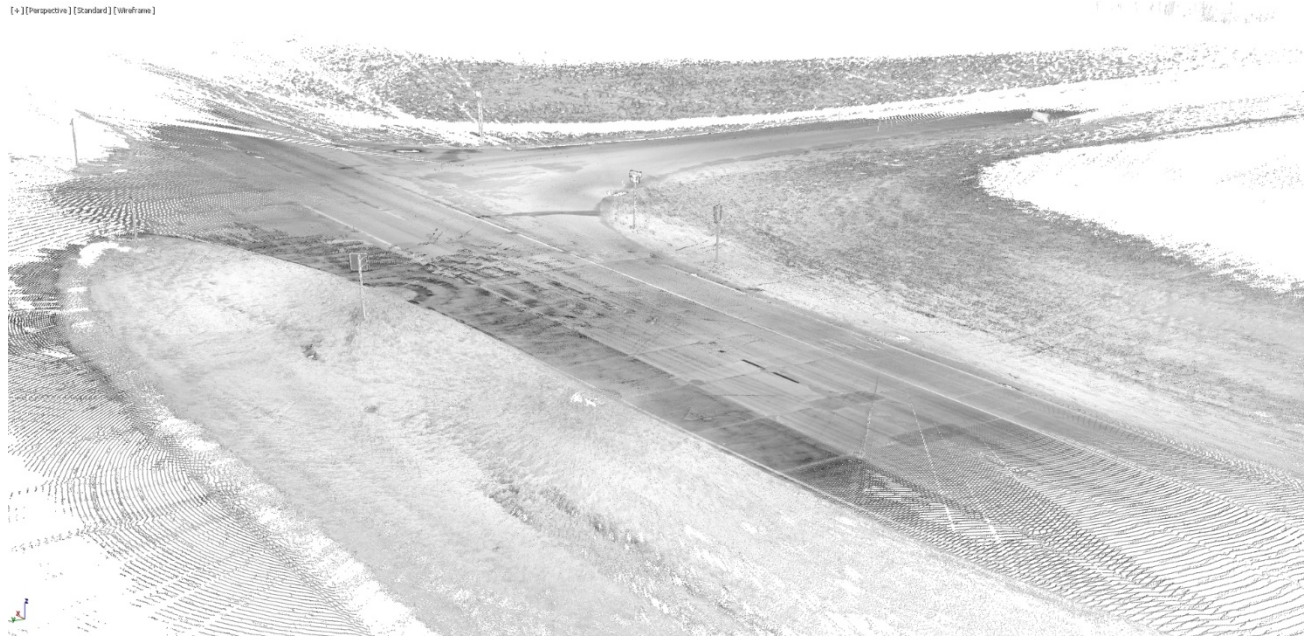
Figure 5 - Kineticorp Scene 3D Laser Scan

Kineticorp also performed a 3D laser scan survey of the scene. A total of five scans were performed with more than 100 million points of data obtained. An image of the scaled 3D model created from the laser scans is shown in Figure 5, oriented so that the eastbound travel direction is from the bottom right to the top left.

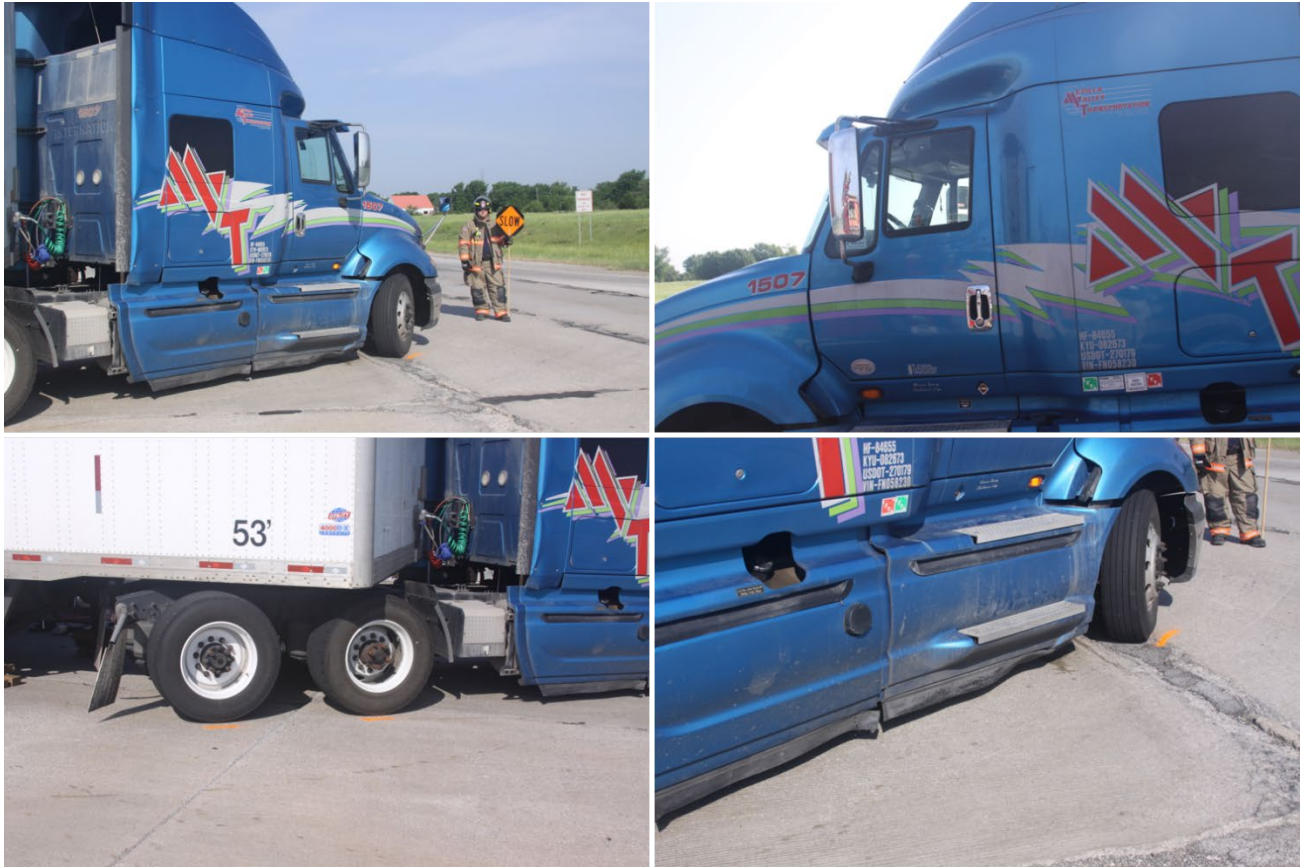
Figure 6 – Subject 2015 International ProStar

2015 International ProStar: Vehicle 1 in this incident, as designated by the Oklahoma police report, is a 2015 International ProStar, driven by Dagoberto Chavez. The International, bearing the VIN - 3HSDJSNR7FN058230, is a 6x4 truck tractor with a 12.4L 6 cylinder Navistar N13 diesel engine.

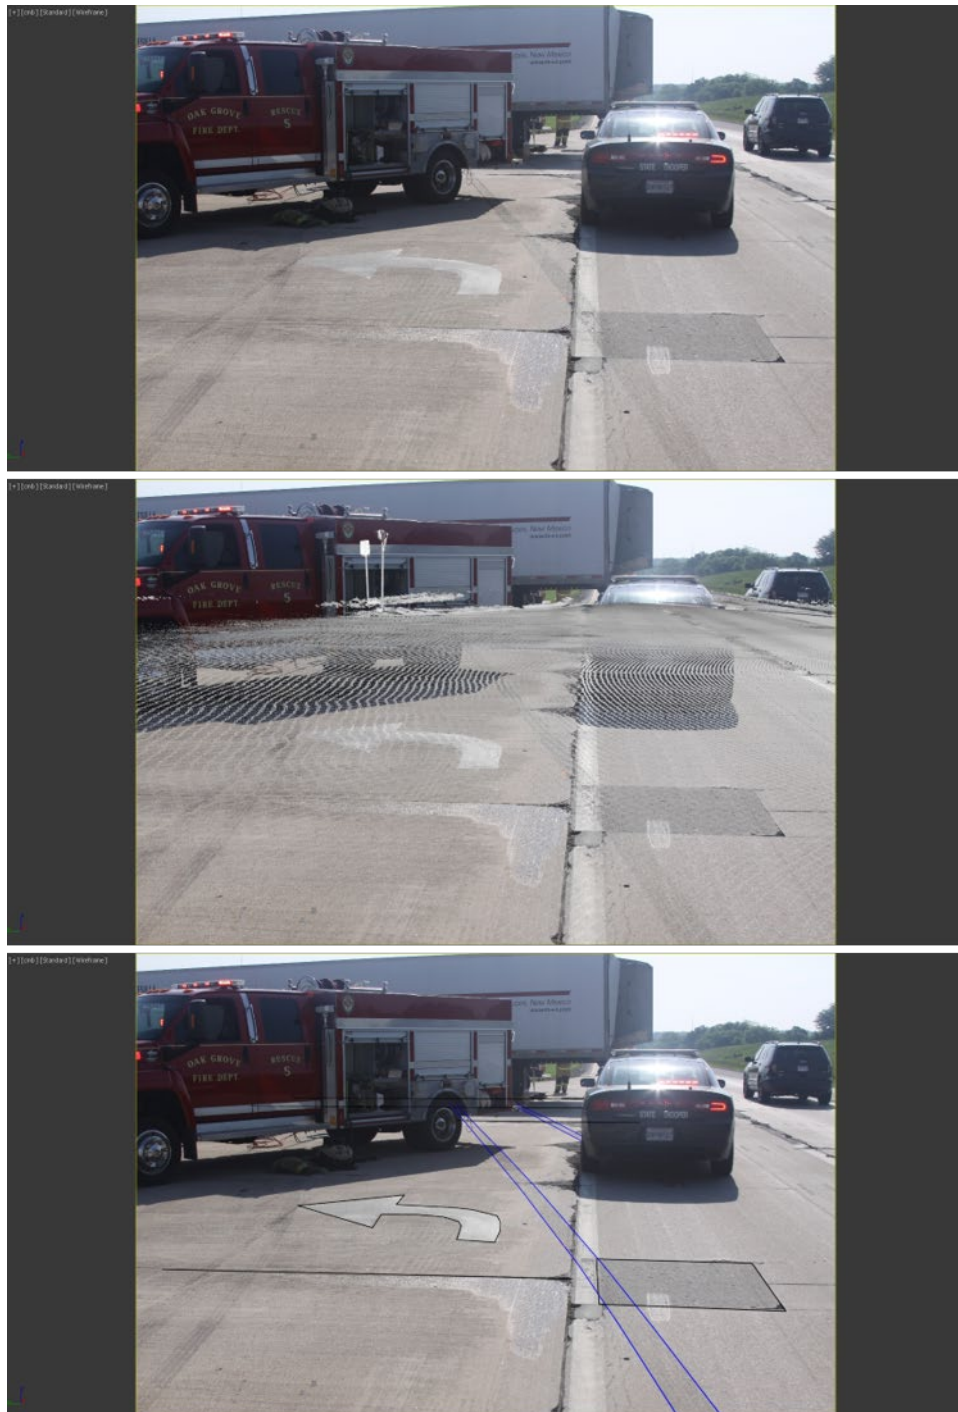
Figure 9 - Camera Matching Process (00-PhotosCombined_Page_010.jpg)

The photogrammetric process involves aligning the computer model with photographs such that the position and characteristics of the camera that took the image are matched in the computer environment with a computer-generated camera. Figure 9 and Figure 10 show provided police photographs of the incident site matched with the 3D laser scans captured by Kineticorp, which allows for accurate extraction and location of physical evidence in the 3D computer environment.

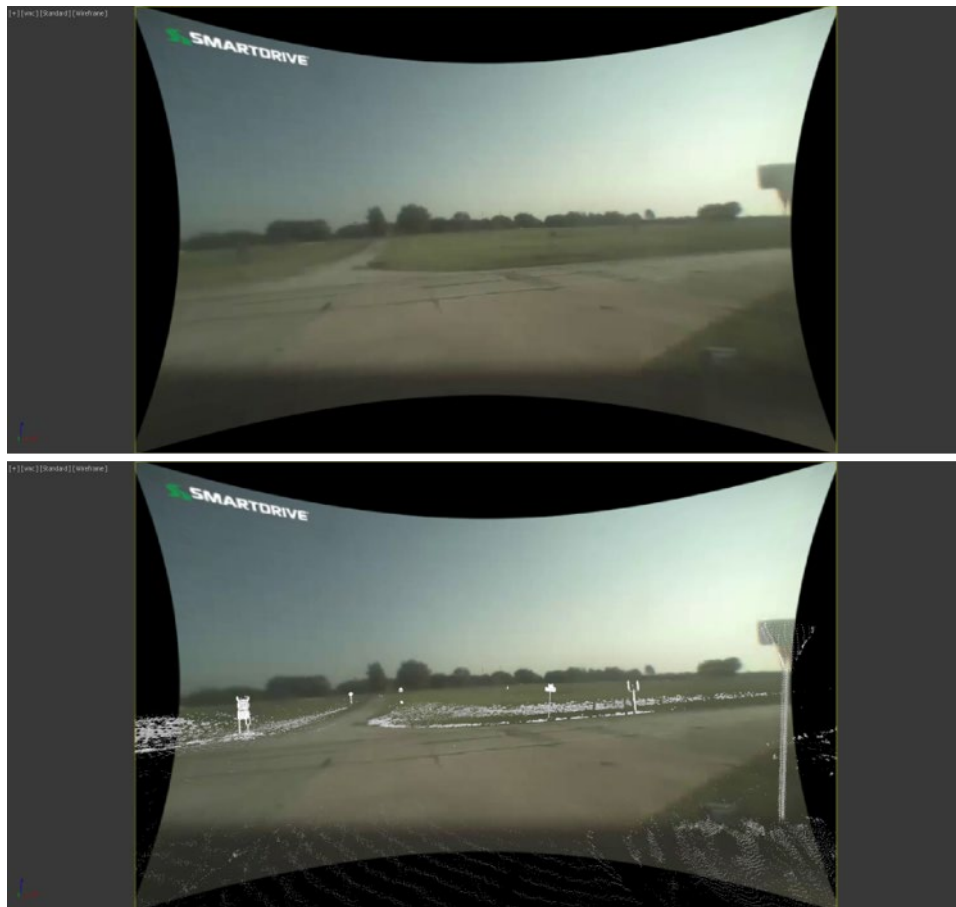
Figure 13 - Camera Matching Process, Extracted Video Frames (frame-101.jpg)

Video-Tracking Analysis: In addition to provided photographs, extracted images from the International's provided DriveCam video were used for photogrammetric analysis. DriveCam analysis is the process of using provided incident video to determine vehicle speeds and positions and is a commonly used form of analysis in the field of accident reconstruction. The analysis shows that the International was traveling approximately 10 to 15 mph at impact. Figure 13 shows extracted video frames matched with the 3D laser scans captured by Kineticorp, allowing for incremental positioning of the tractor throughout the incident sequence.
